Riverstone Natural Roofing Slate

**the geology, test
performance and use**

This report concerns the geology, test performance and use of Riverstone natural roofing slate from Argentina. The report principally draws information derived from a variety of independent sources on behalf of SSQ Group. Most of the test results are derived from STATS Consultancy who have commented on the potential performance of the slate for roofing purposes.

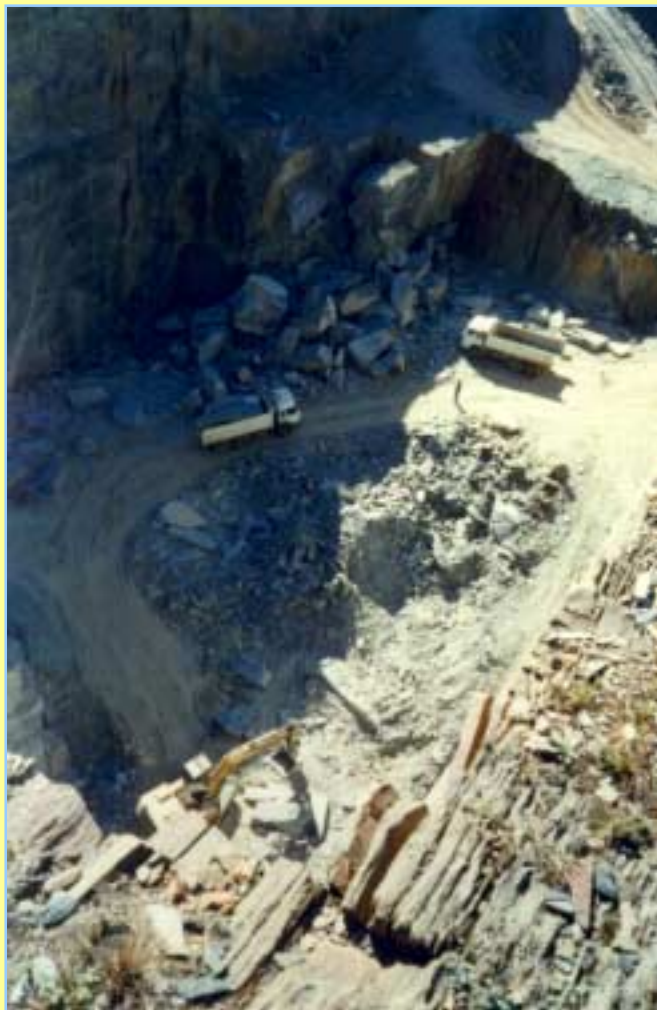
Left: La Represa quarry. The beds are clearly vertically inclined (bottom right).

Other structures influencing the geology include the presence of quartzitic veining related to tectonic movements and decompression of the rock. Joint sets are exploited during quarrying to assist extraction. For commercial purposes, the largest blocks are obtained from deeper levels within the quarry.

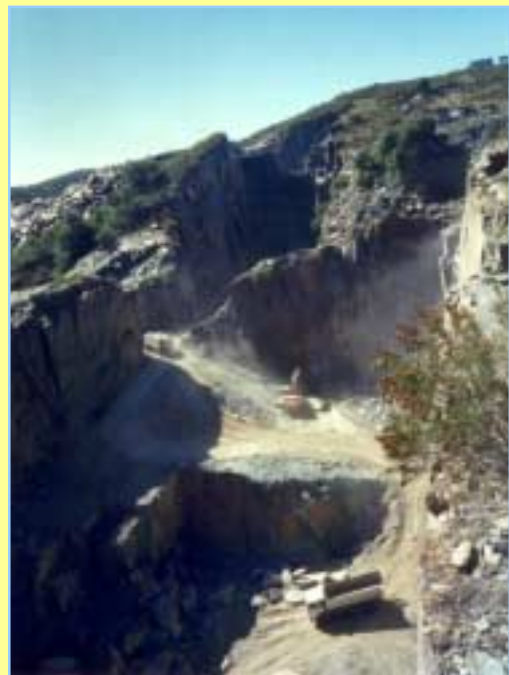
Above: La Represa quarry. Larger blocks are obtained from deeper levels.

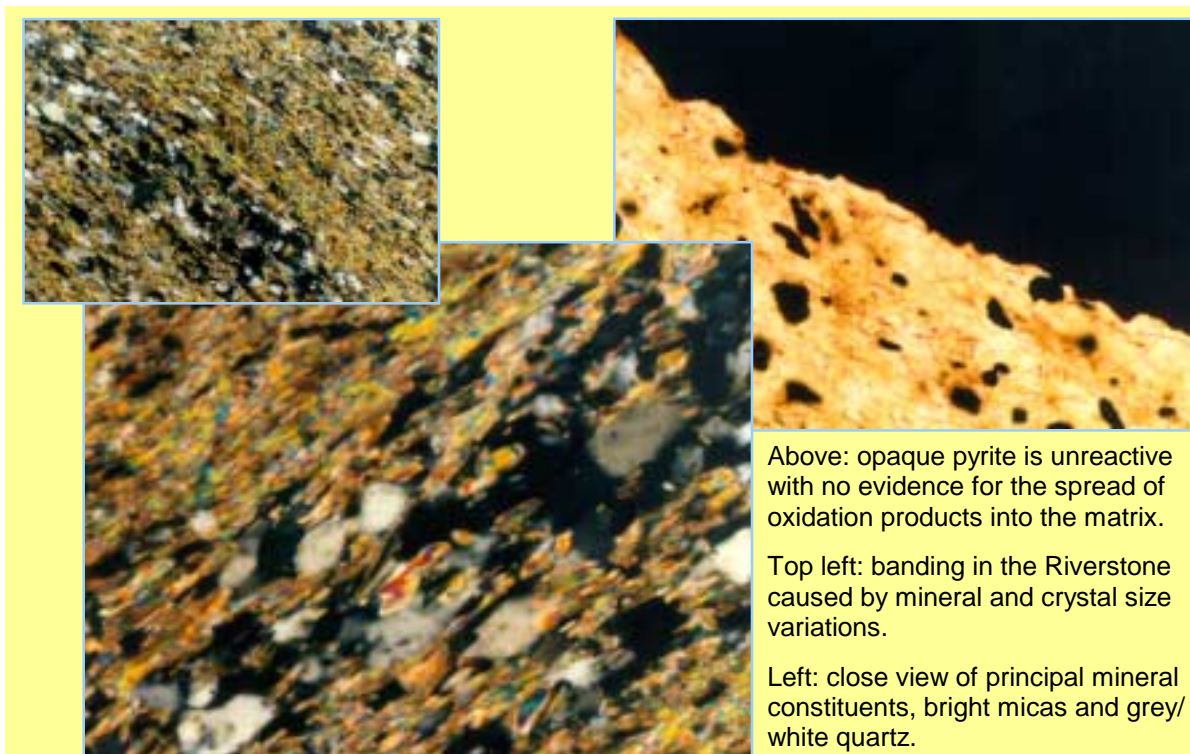
These three photographs are all views taken through the petrological microscope

The phyllosilicate minerals have a platy structure and are typically aligned sub-parallel to the primary cleavage with a 'preferred orientation'. The quartz is clearly distinguished amongst the phyllosilicates, appearing micro-granular. The larger quartz grains are typically flattened and elongated sub-parallel to the primary cleavage. The pyrite traces occur as well-formed crystals. Calcite occurrence is irregular, usually as large crystals surrounding the other constituents (porphyroblastic texture).
